Examining the Interrelationships of Microclimate, Construction Performance and User Behaviour to Inform Design Strategies

MARY HANCOCK, DR FIONN STEVENSON

This paper presents preliminary data collected from the first year of a two year post occupancy study of a semi detached house, built to EcoHomes Excellent standards. The research project aims to identify a minimum level for monitoring which can reliably indicate the building performance and can produce comparable data.

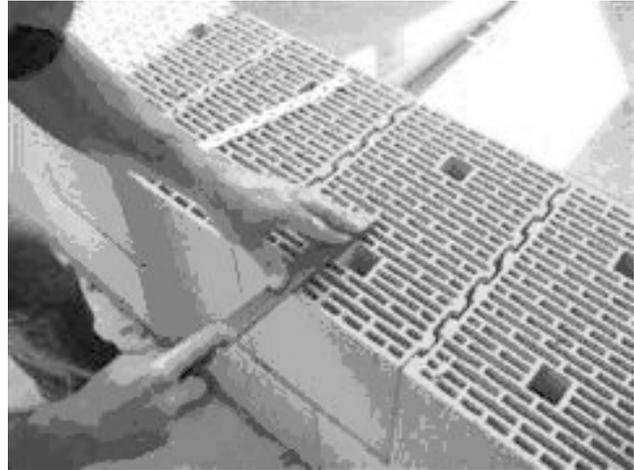
Figure 2: Ziegel walls blocks showing cellular construction [6]

The nine houses are built on a disused quarry in a very pretty Oxfordshire village. They were marketed on the strength of their low energy use and healthy internal environment. The developer chose to use a single ziegel block wall to achieve the required thermal performance. Ziegel blocks are a new introduction to the UK from Germany (though Ibstock, in 2009, is developing plant to make the blocks in the UK); they are thin walled cellular clay blocks (fig 2). Their chief advantages are perceived to be the speed of laying, the breathable construction and quick drying, and the reduction of risks from interstitial condensation. They have a low embodied energy in comparison to a regular masonry construction and achieve a good thermal performance (u-value of 0.23 W/m²K) with a single block 365mm thick, plastered internally and rendered externally. The blocks are made from clay that has been mixed with sawdust particles so that these burn to form a micro porous structure when they are fired. They are thin bedded, effectively glued together, and because of the lack of a forgiving mortar

bed they are planed to very close tolerances after firing. They are quite brittle in use so tradesman must be careful to avoid damaging them before the surfaces are rendered or plastered.

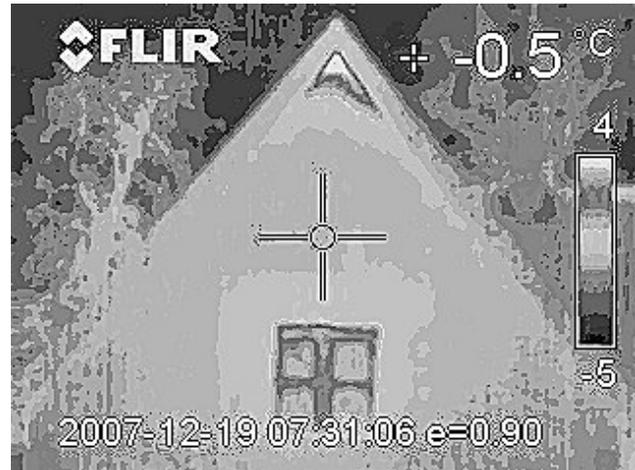
Figure 3: Thermal image of stone clad gable, the light areas show areas of significant heat loss at apex of roof

- the ziegel blocks need particularly careful detailing in areas where they have been cut- for example into the gable. This observation was confirmed by observation on other sites using ziegel blocks. The thermal image of the front elevation (fig 3) shows the greatest heat loss to be at the apex of the gable where the blocks are cut and a complicated junction, with large surface heat loss area, is made with the barge boards and rafters. The window frames are also a significant heat loss area, performing less well than the glazing.

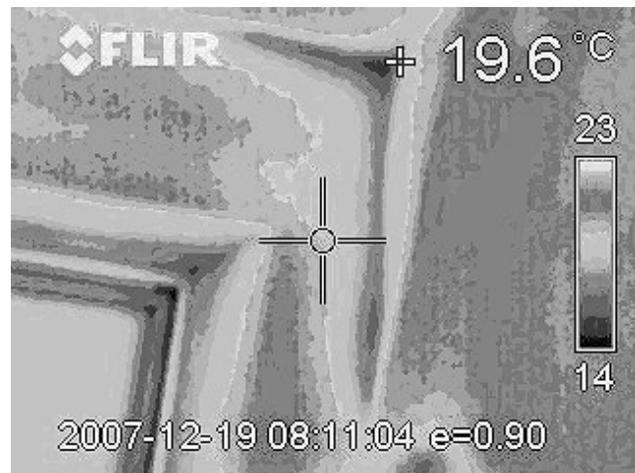
Figure 4: Thermal image of external corner of east bedroom, first floor; the dark areas show cold internal corners,

- Some areas of the internal walls, particularly into the internal corners were cold. (fig 4)

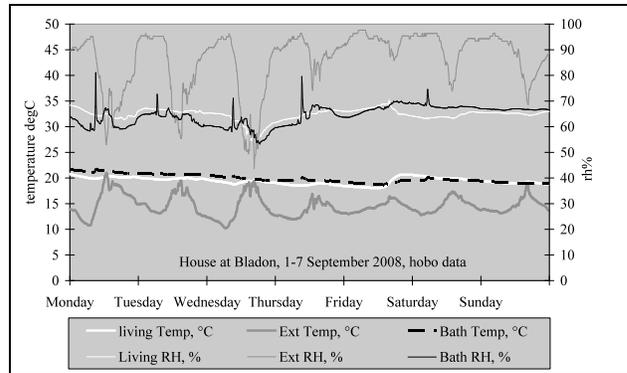
Figure 5: Temperatures and RH, September 2008

The record of temperatures and relative humidities confirmed that the house temperatures were very steady at around 20K (fig 5) with temperatures varying by less than 2 K over a typical week, but that it suffered with high humidity in its first months of occupation.

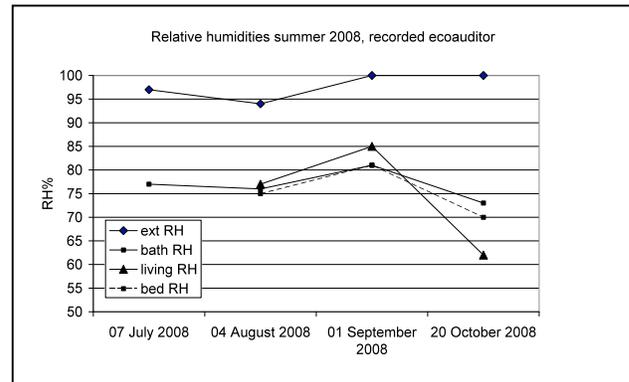
Figure 6: RH recorded summer 2008

As the construction had been particularly chosen to achieve a healthy environment, the generally high internal RH was a source of concern, particularly since the user activity was minimal in relation to shower use, cooking, washing and other activities that might raise relative humidity levels. However the passive stack appears to be effectively reducing the relative humidity peaks following showering to the ambient RH conditions (fig 5). Figure 6 indicates the high summer values of RH (typically above 70% in the living room) which started to reduce into the autumn 2008 (fig 7).
